DIAGNOSIS OF A MILL USED FOR POWDER SLAKED LIME MANUFACTURING

ABSTRACT

The main aim of this paper is to present the methodology and the experimental set-up used to determinate the causes of the gearbox crack of a mill used for powder slaked lime manufacturing. There are presented the equipment used, the methodology of equipment calibration and the realised measurements. At the end there are mentioned the main causes that can develop the gearbox frame collapse.

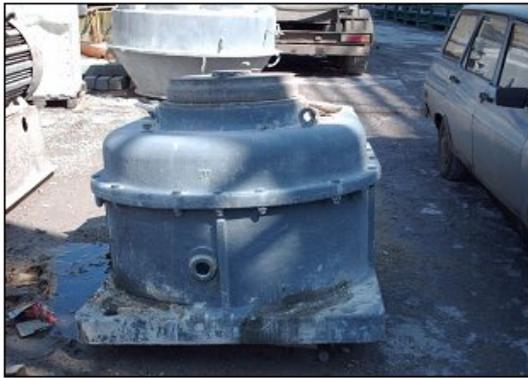
During the technological process of the powder slaked lime manufacturing there are used large mills (Figure 1,a & b) where slim balls are pressed in a system consisting of a rotating table and two pressing rolls (Figure 1,c). As a result of the technological process there are developed shock impulses with large amplitude that can have a bad influence on different parts of the mill. The most affected part of the whole mill is the gearbox that is situated between the electrical engine that provide the rotation motion and the rotating table. As a result of the shocks impulse the frame of the gearbox cracked around its base (Figure 2).

Figure 2. Cracked gearbox frame around its base

- The high level of the vibration amplitude, situated on the gearbox frame in the same place with the rotating mass is caused by a high level of the bearing wear and shocks that are developed during the manufacturing process;

- The assembly mill and foundation do not work as a single structure;
- The maximum value of shock is around 8g that is larger than the value considered in the mill design.

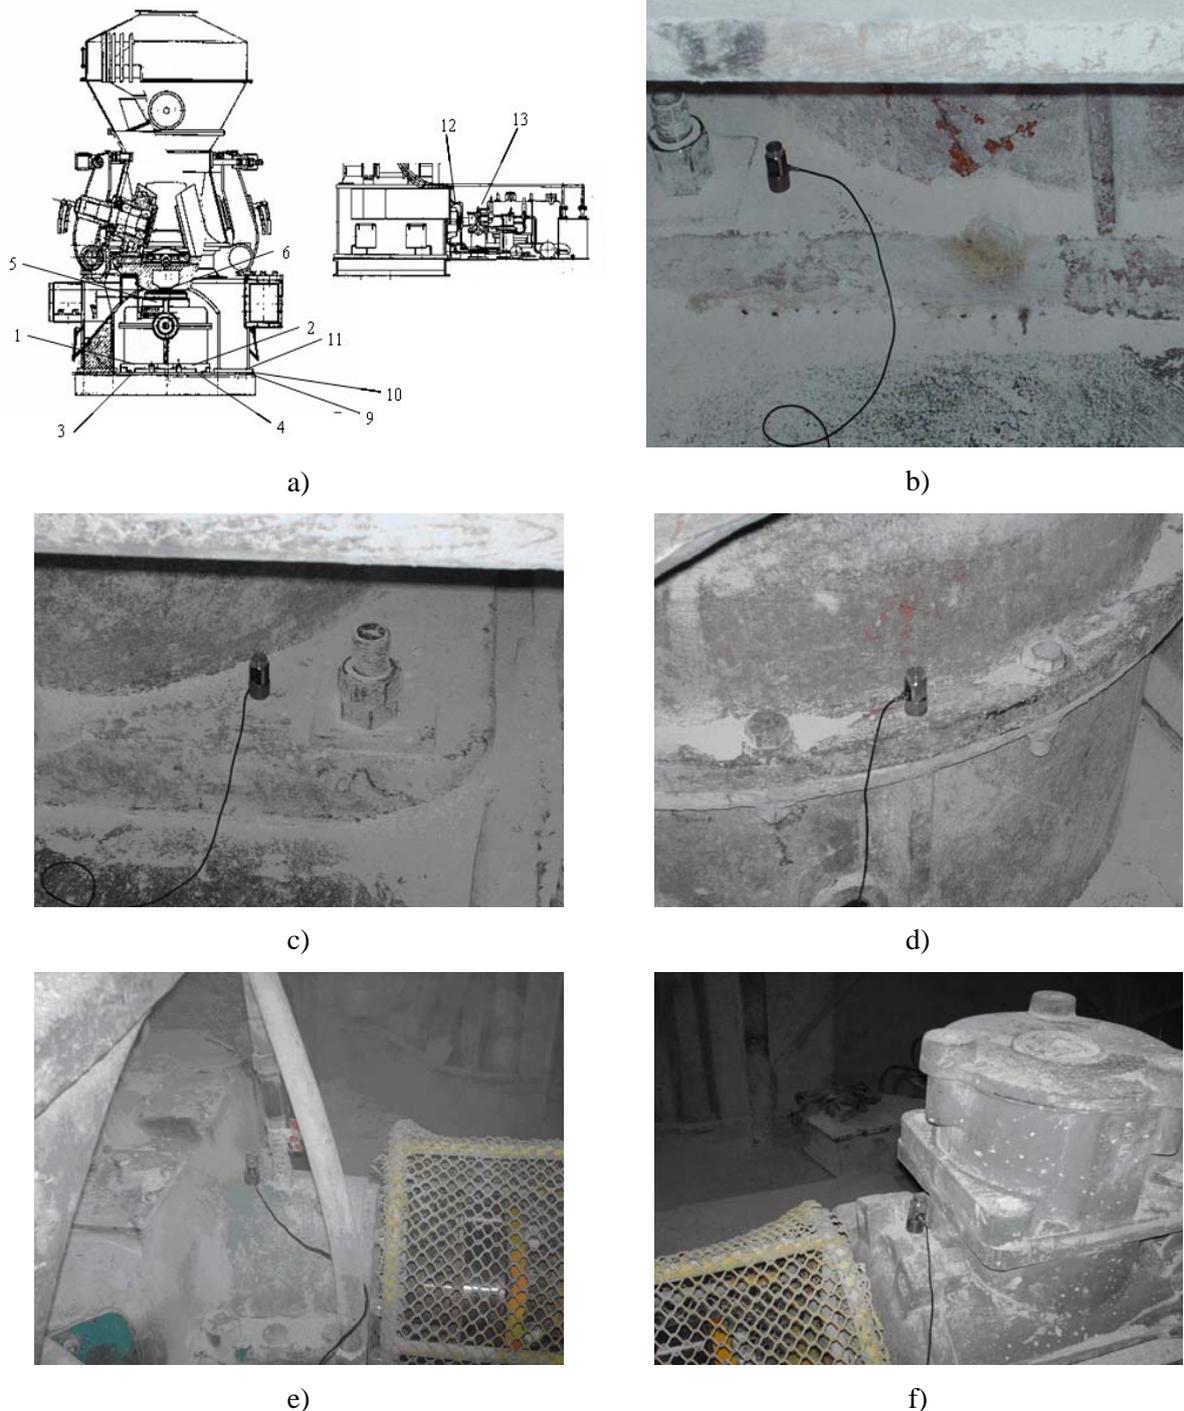
Figure 5. Points of measurement: a) general presentation of the measurements points; b) point 1; c) point 2; d) point 6; e) point 12; f) point 13.

- The high level of the vibration amplitude in point 1, that is situate on the base plate of the gearbox was cause by the wrong mounting of the screw and nut;

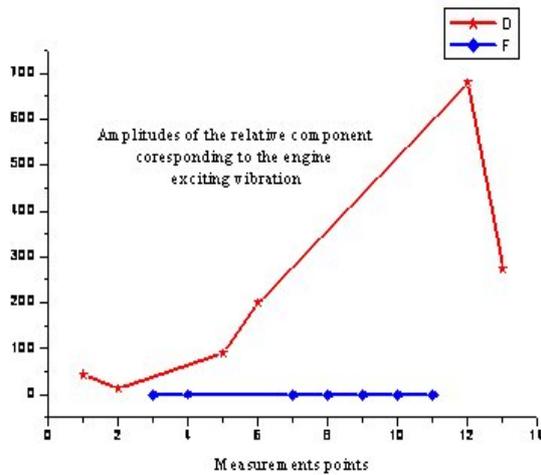
The highest level of the measured signal was detected at the entrance point of the gearbox (point 12 – Figure 6,a and Figure 7).

Figure 6. Amplitudes of vibration signal measured in different point of the gearbox

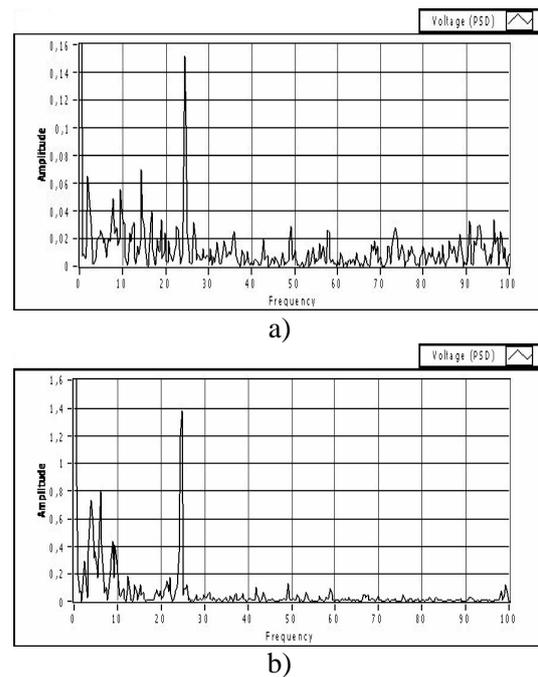
Figure 7. Signals from point 12: a) without load; b) during manufacturing

- There are different levels of the vibration amplitudes of the mill structure in the considered points of measurements (Figures 5 and 6);
- The highest level of vibration amplitude is located in point 12 (Figure 7), on the gearbox, that is situated in place where is the radial-axial bearing at the rotating motion entrance in gearbox. As a possible cause was considered the wrong position (wrong connection) of the main shaft of the gearbox and the electric engine rotor;
