## TRIBOLOGICAL CHARACTERISTICS OF GEARS REPARATORILY HARDFACED WITH “HARD” AND “SOFT” ADDITIONAL MATERIALS

Dr. Eng. Svetislav Lj. Markovic,  
Higher Technical School, 32000 Cacak,  
Svetog Save 65, Serbia, E-mail: svetom@ptt.yu,

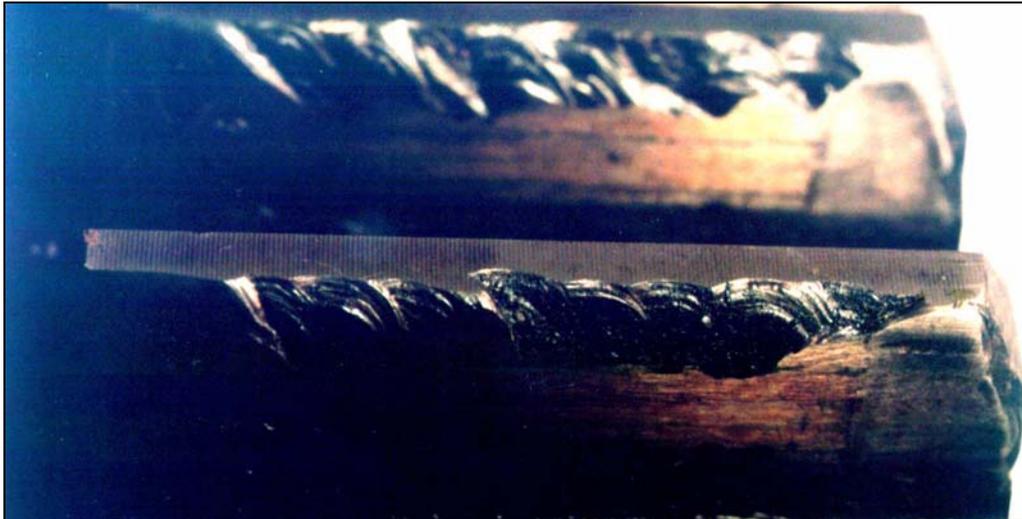
The first initial pits in the teeth hardfaced with DM UTP 570 were spotted in the transition of the two passages (facings), which is situated on the head of the tooth. They appeared after  $70 \cdot 10^6$  cycles. After  $98 \cdot 10^6$  cycles, about 32% of the working surface of the most endangered tooth was damaged (Figure 2). It must be noticed that mainly heads of these teeth were damaged, while on the other surfaces separate pits of smaller dimensions and less depth are noticed.

*Figure 2. Working surfaces of the teeth hardfaced with additional material UTP 670 after  $98 \cdot 10^6$  cycles*

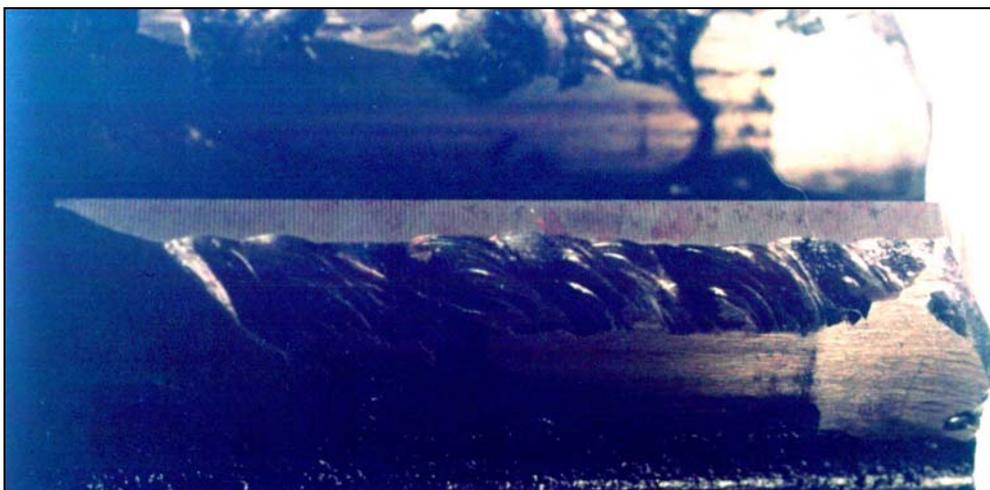
At the teeth MMA hardfaced with electrode EVB2CrMo, and then cemented, tempered and released, the incidence of the initial pits is noticed after  $70 \cdot 10^6$  cycles. The legs of the teeth, as well as the heads were destructed, but the bridging over of these independently created damages by wedges which are almost vertically in relation to the direction of the tooth is also noticed (Figure 3). After the ceasing of investigation (since  $98 \cdot 10^6$  cycles were realized) the surface which was influenced by the destructive pitting totalled around 50% of the total working surface of the side of tooth.

*Figure 3. Teeth damaged by pitting and hardfaced with additional material EVB2CrMo after  $98 \cdot 10^6$  cycles*

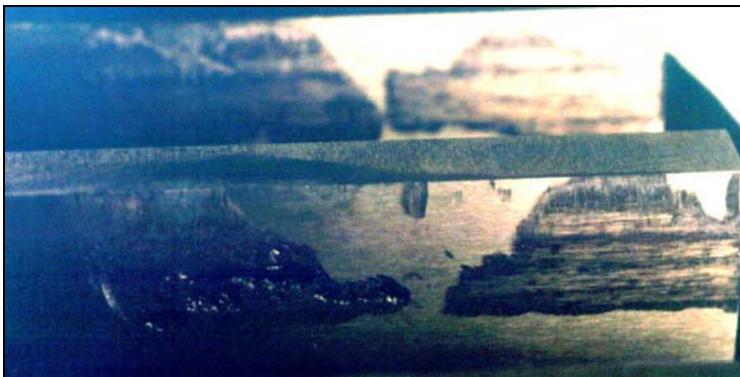
The beginning of pitting, that is the incidence of the initial pits, regarding the newly-made teeth, is noticed very early, at the  $69 \cdot 10^6$  cycles. Gradually and very slowly, the other pits started to appear. The incidence of the initial fatigue holes at the teeth of the newly-made gears is the “privilege” exclusively of the leg of the tooth. Only considerably later (after 12-15 million of cycles), the signs of the destructive pitting started to appear also on the legs of the new teeth. On Figure 4 pits created under the diameter pitch of the tooth in the phase immediately before the creation of the wedge are clearly noticed. The special interesting thing is the data that also on the photograph the change of the colour of the working surfaces of the teeth due to fatigue, which precedes the creation of the destructive pitting, can be easily seen. The fact is that the development of the destructive pitting regarding the new teeth is a little bit slower than regarding the regenerated ones. At the completing of the investigation, that is after  $98 \cdot 10^6$  cycles, it is estimated that 18% of the working surface of the side of the tooth is affected by pitting (Figure 5). It is also important to point out that all the teeth are of the similar level of damage, which is not the case at the hardfaced ones, where the differences in the level of damage (in the percentage of the surfaces destructed by pitting) of certain teeth are considerably greater.

*Figure 4. One of the initial phases of the destructive pitting of the working surfaces of the teeth of the newly-made gears*

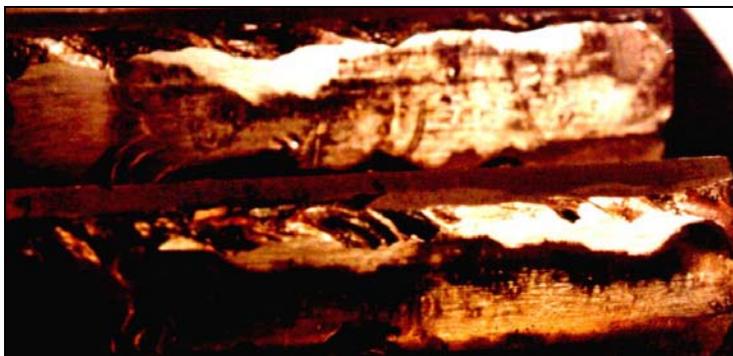
*Figure 5. Newly-made teeth damaged by the destructive pitting after  $98 \cdot 10^6$  cycles*
