CRACKING PARTS OF THE ROLLING BEARING

J. Bezecný, J. Šišáková
Faculty of Industrial Technologies,
I. Krasku 491/30, 020 01 Púchov,
Slovakia, bezecny@fpt.tnuni.sk

ABSTRACT

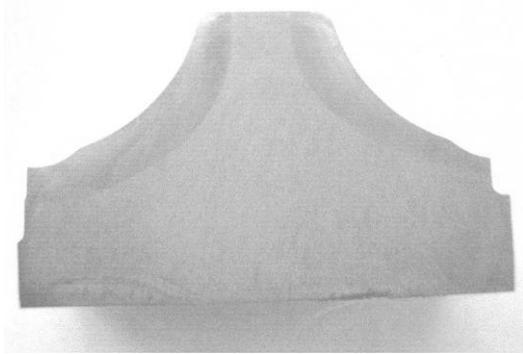
Microstructure was evaluated on the cross-section through the surface quenching scoring – figure 1. Depth of layer is unable, left side of scoring is value of depth of 3 to 5mm, right side of scoring has values of 2,8 – 4,5 mm. the smallest depth of quenching layer correspond to places with the smallest hardness. Microstructure of surface quenching layer is created by fine needle low tempering martensite, figure 3. Places with lower hardness – martensite allocate higher degree of tempering – figure 2. Core microstructure is created by heterogeneous sorbite which responds to enriched case, figure 4.

Figure 1. Surface quenching part.

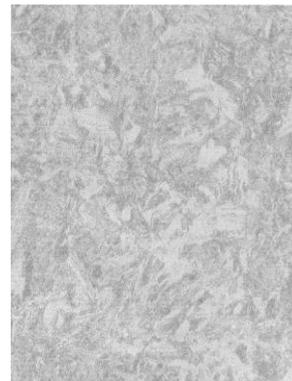
Figure 4. Core micro structure

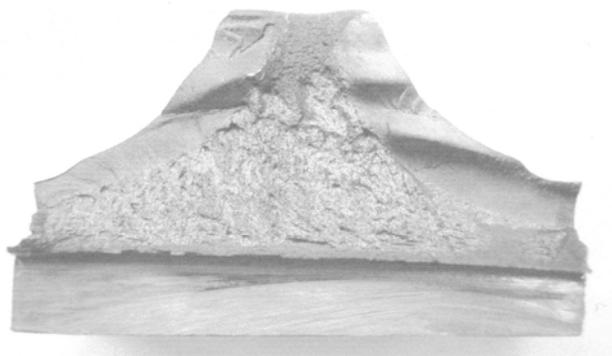
Microfractographic analysis was realized on REM TESLA BS 301. There was evaluate a laboratory fracture – figure 5.

Figure 5. Fracture macro morphology

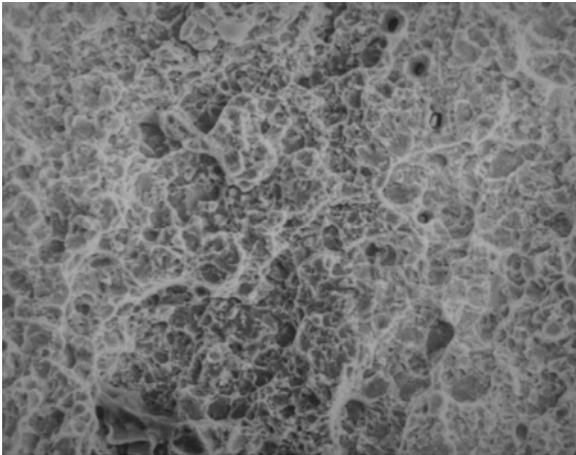
There was observing two different failure micro mechanisms in surface quenching layer. In areas with lower hardness obtain transgranular dimple fracture – figure 6; in areas with higher hardness we can see the defective brittle intergranular cleavage fracture – figure 7.

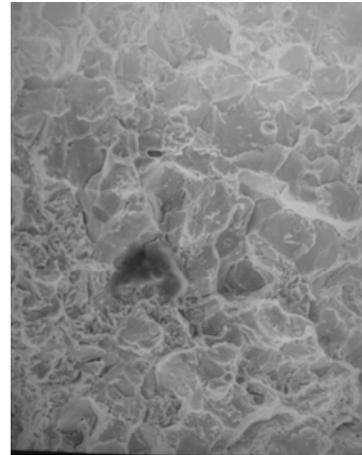
Heterogeneity of microstructure and material embrittlement in surface quenching layer, which were induce no optimal conditions of quenching are the main reason of cracking the outer ring of rolling bearing.

We advise to make sure the brittle fracture properties on REM by optimization of surface quenching regime, whereas the control of hardness and microstructure give uncertain useful properties of analyzed detail.

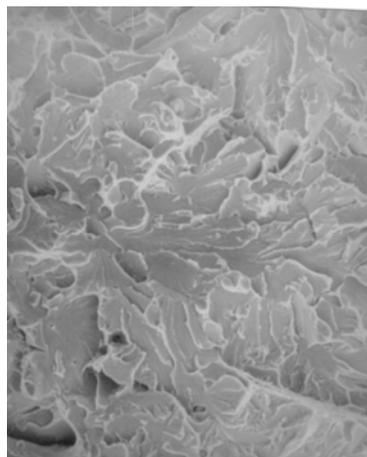
Transcrystalline quasi cleavage or cleavage mechanism was observing in region of core microstructure – figure 8.

Figure 8. Core micro morphology
