IMPACT TOUGHNESS OF STEAMLINE MATERIAL 14MoV6-3 AFTER LONG-TERM EXPLOITATION

Investigated material is taken from the Unit 5 main steamline (ø245×28mm) that operated at temperature 540 °C and pressure 13,5MPa, in thermal power plant TE Kakanj, Bosnia and Herzegovina. Sample of steamline exploited material 14MoV6-3 was cut in 2008 because of residual life estimation. Virgin material was also cut from the steamline material 14MoV6-3 (ø245×28mm).

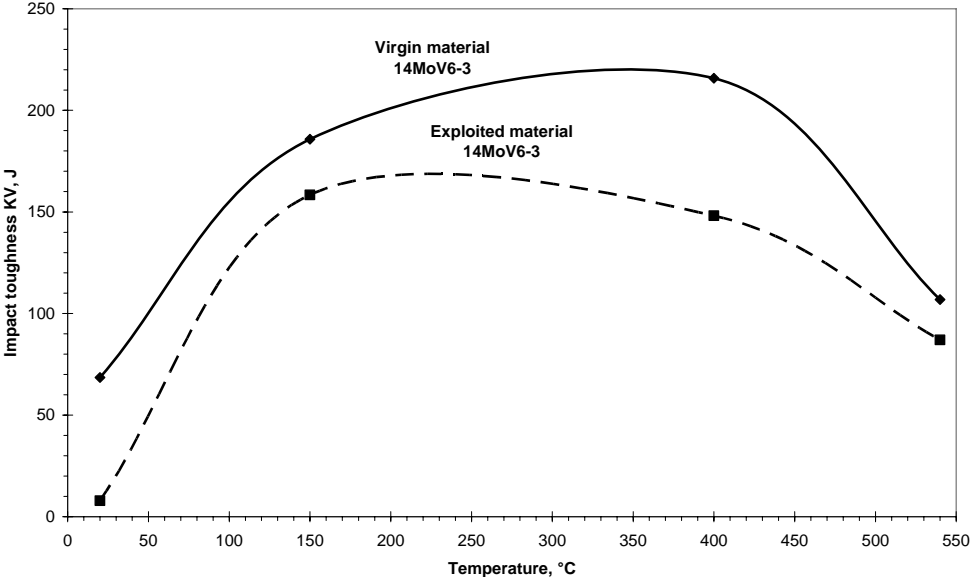
Figure 1. Impact toughness testing results of virgin and exploited material 14MoV6-3

From the results of impact toughness testing shown in Figure 1 it is notable that the total impact energy (impact toughness) increases slightly up to 400 °C for virgin material 14MoV6-3 and up to 150 °C for exploited material 14MoV6-3. It reduces significantly, but not drastically above 400 °C for virgin material and above 150 °C for exploited material, so that its values are still more than sufficient at steamline service temperature 540 °C.

According to results of impact toughness testing it is also possible to notice that the transitional temperature of exploited material 14MoV6-3 has increased above room temperature, indicating significant change in the material behavior at impact load.

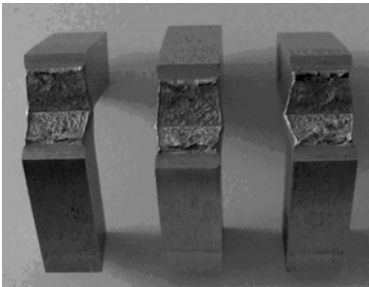
Figure 2. Tested V-notch specimens of virgin steamline material 14MoV6-3 at 20 °C

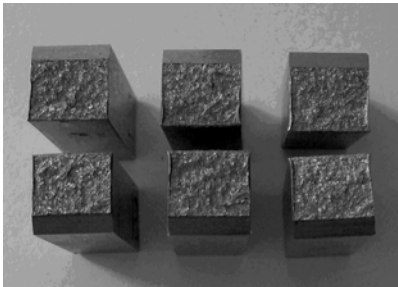
Figure 3. Tested V-notch specimens of exploited steamline material 14MoV6-3 at 20 °C

The most important result of exploited steamline material impact toughness testing is extremely low value of total impact energy (impact toughness) at room temperature 20°C (average value is 7,89 J), which is significantly beneath the allowed value of 41 J according to normative DIN 17175/79. Also, in Figure 3 tested specimens of exploited steamline material shows exceptionally brittle character of fracture at room temperature (20 °C). Anyhow, at higher temperatures the impact energy of exploited steamline material is sufficient, and character of specimens fracture is more ductile.
