INVESTIGATION OF PIPE MATERIAL CONDITION IN AMMONIA PLANT

The condition of pipe material used in an ammonia production plant is analyzed. The pipes are made of high alloyed Ni-Cr and Cr-Mo alloyed steel for high temperature (523°C) and high pressure (126 bar) operation. Media inside the pipes is superheated steam that is heated by natural gas combustion. The condition of pipes that have been exposed to high pressure and temperature is analyzed, and the corrosion damages are observed at outer side of the pipe. These damages caused the decrease of the mechanical properties, and therefore, the lifecycle of the pipes also decreased.

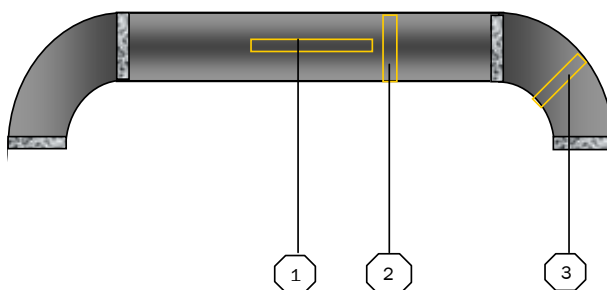
Figure 1. Pipe and pipe elbow (1, 2, 3 – test-tubes used for testing)

1 testing of tensile characteristics ($R_{p0,2}$, R_m , A_5)

2, 3 chemical composition of material, testing of microstructure, dimension control

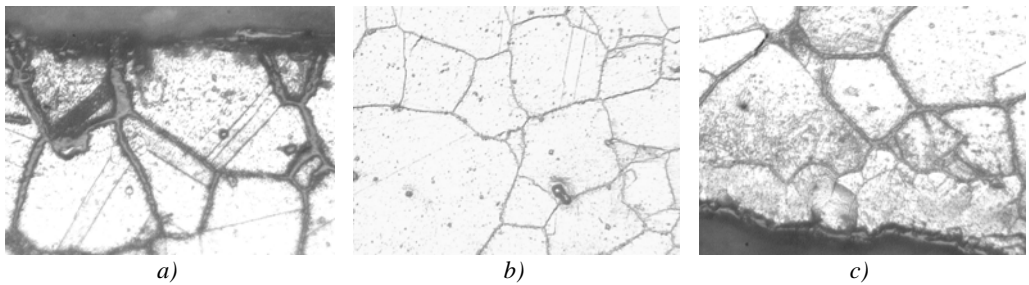
Figure 2. Metallographic images of the pipe structure, 400:1 magnification

- a) outer rim of the pipe wall
- b) middle of the pipe wall
- c) inner rim of the pipe wall

Microstructure of the outer rim of pipe shows visible damages of the surface layer in a form of intercrystalline corrosion with depths of 0,06 mm. Microstructure after etching is similar to the average grain size (4 to 5 of ASTM scale). Large magnifications show decay of grain boundaries (particularly at the outer rim of pipe wall). Decay process (with precipitation) can be seen in the middle of pipe wall (Figure 2.). Microstructure of the pipe elbow wall (Figure 3.) shows decay and damages of the inner rim of pipe wall. Grain size varies (3 to 5 according to ASTM scale).

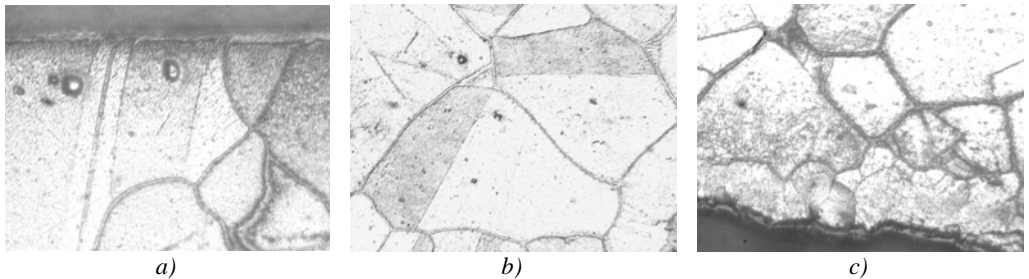
Figure 3. Metallographic images of the pipe elbow structure, 400:1 magnification

- a) outer rim of the pipe elbow wall
- b) middle of the pipe elbow wall
- c) inner rim of the pipe elbow wall
