RESEARCH INTO THE EFFECT OF CORROSION ON DAMAGED THERMAL POWER PLANT EQUIPMENT

The research was conducted at several power plants where defects of boiler exchangers were detected. The analysis of damages on fire tubes and exchangers were performed considering selected materials and influence of different types of corrosion. Critical areas on both the side of flue gasses and the side of water/steam working fluid were considered.

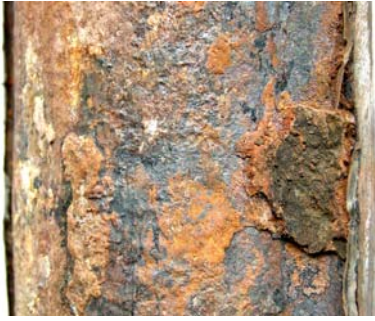
- all along both sides of the tube weld on the fire tube outer surface, deposits of the combustion and corrosion products are formed
- on the other half of the outer surface, insulation side, there are no visible processes of deterioration
- inner side of the tube (water) has no visible changes and defects.

Figure 4 Tube fire side outer surface

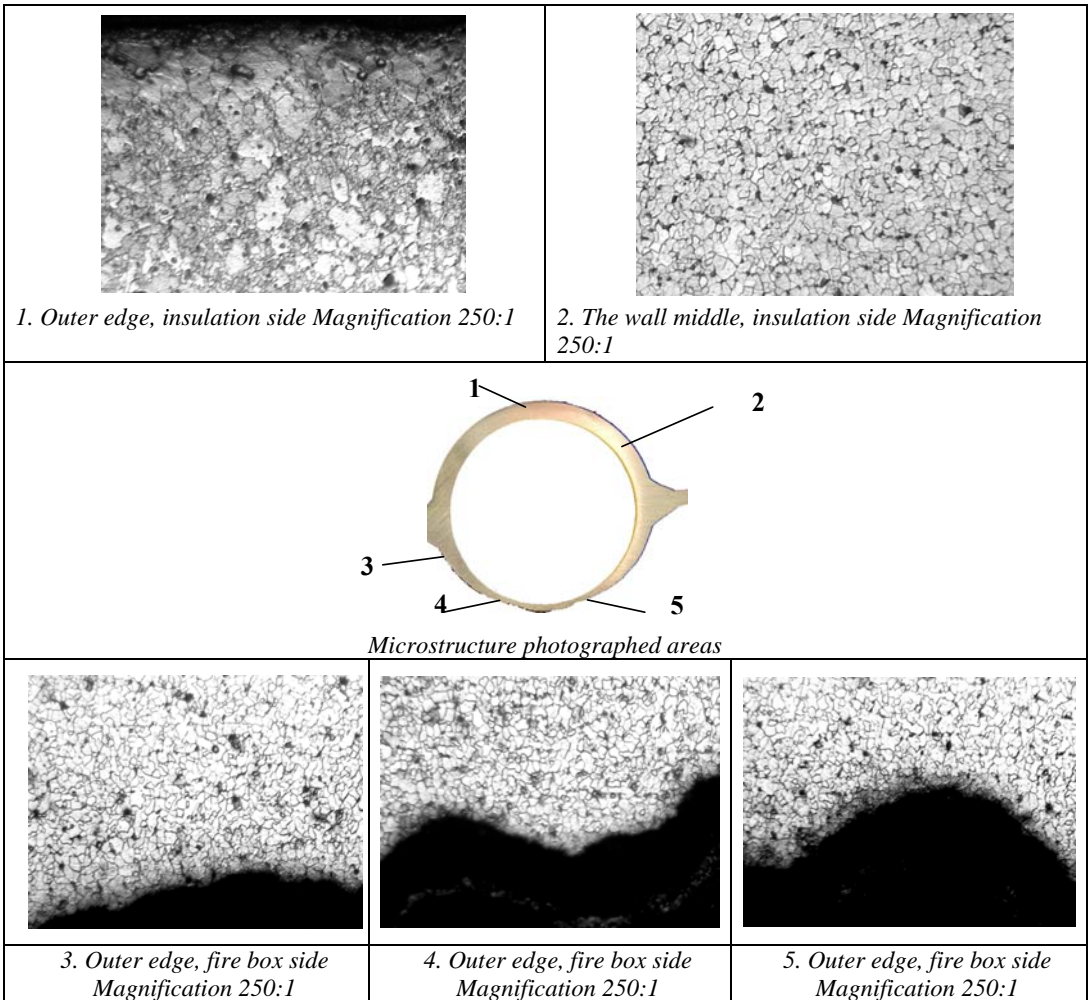
Figure 7 Photographed areas and the damaged tube microstructure photographs
