MICROSTRUCTURE DEGRADATION AFTER PROLONGED EXPLOITATION OF HEAT RESISTANT STEEL 14MoV6-3

Damir Hodžić,
Faculty of Mechanical Engineering
Vilsonovo šetalište 9, Sarajevo
Bosnia and Herzegovina

Ismar Hajro
Faculty of Mechanical Engineering
Vilsonovo šetalište 9, 71000 Sarajevo
Bosnia and Herzegovina

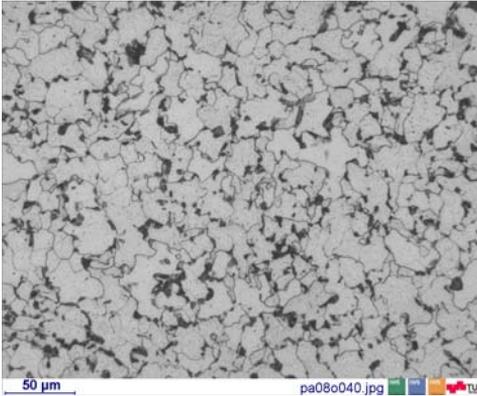
Figure 1. Microstructure of virgin steamline material 14MoV6-3, magnification 200x, [6]

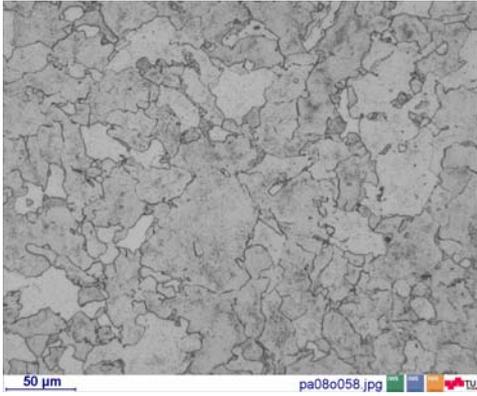
Figure 2. Microstructure of exploited steamline material 14MoV6-3, magnification 200x, [6]

According to previous investigations of this material with similar service conditions, that are published in scientific journals, the initial microstructure of the 14MoV6-3 low-alloyed steel features the mixture of bainite with ferrite, sometimes with a small amount of pearlite. Occurrences of the significant amount of the M_3C carbides and numerous, very fine MC type ones, are identified in such material. The final structure image after prolonged exploitation is ferrite with rather homogeneously distributed precipitations inside grains and chains of the significant amount of precipitations on their boundaries, [7]. Results of microstructure investigation that are presented in this paper mainly can confirm previous facts, but in addition to mentioned microstructure evolution, there is also a significant growth of ferrite grain size after long-term operation at elevated temperature.

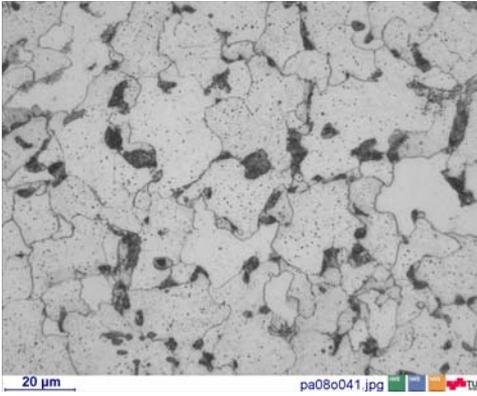
Figure 3. Microstructure of virgin steamline material 14MoV6-3, magnification 500x, [6]

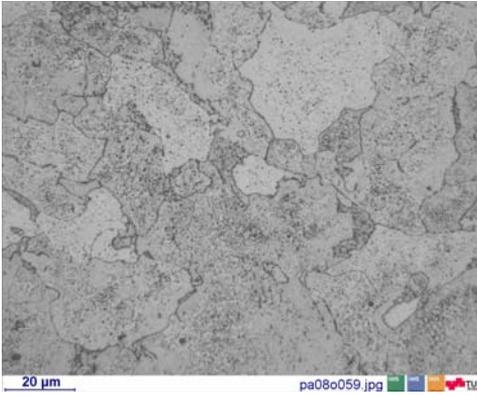
Figure 4. Microstructure of exploited steamline material 14MoV6-3, magnification 500x, [6]

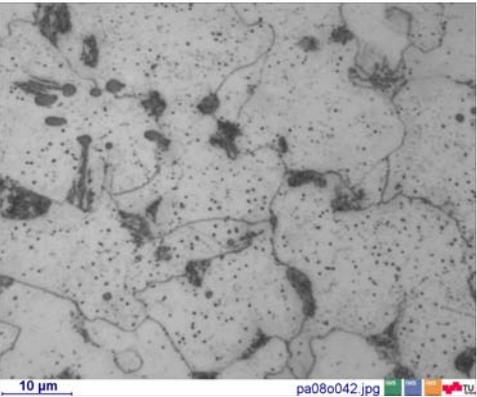
Figure 5. Microstructure of virgin steamline material 14MoV6-3, magnification 1000x, [6]

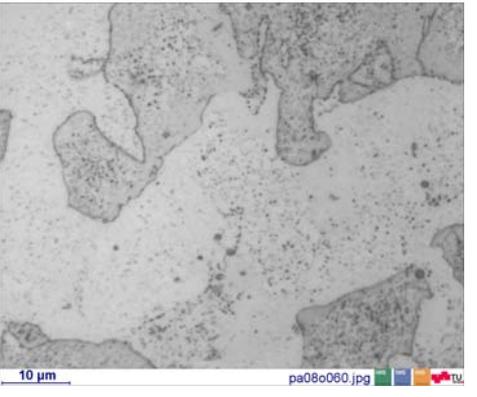
Figure 6. Microstructure of exploited steamline material 14MoV6-3, magnification 1000x, [6]
