## HAZARDOUS WASTE MANAGEMENT AND ECOLOGICAL CONSEQUENCES

*Fire, explosion and chemical incidents most frequently occur either in chemical plants, military warehouses or during the transportation of dangerous and toxic substances, nevertheless they might appear in terrorist attacks, demolitions or sabotages. In this paper we shall present an instance of an explosion that occurred in the military warehouse near Paraćin. The explosion was caused by inadequate storage of the ammunition that was out of use, thus it can be referred to as hazardous waste.*

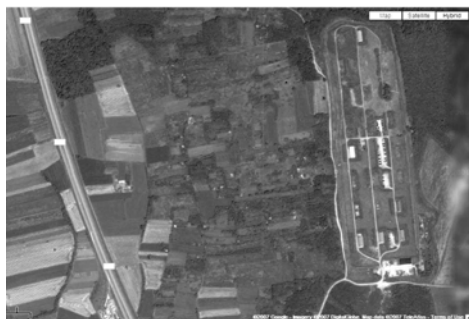
Image of the warehouse prior to the explosion

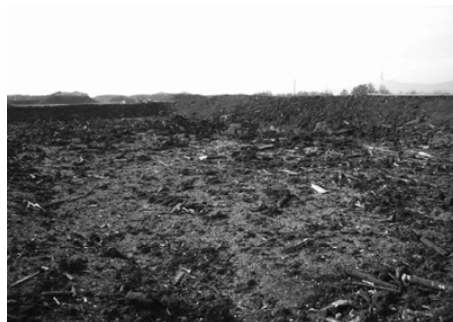
Image of the warehouse after the explosion

Early in the morning of October 19<sup>th</sup> 2006, around 3.50 a.m., an explosion in the Serbian Armed Forces warehouse on „Karadjordjevo brdo“ took place.

In the explosion of Serbian Armed Forces warehouse near Paraćin 1,300 tons of mine explosive devices detonated. If we estimate net quantity of explosive in some kinds of ammunition we come to the datum that 181,365 kg of explosive detonated 146,020 kg of which was trinitrotoluol and 35,345 kg was hexogen.

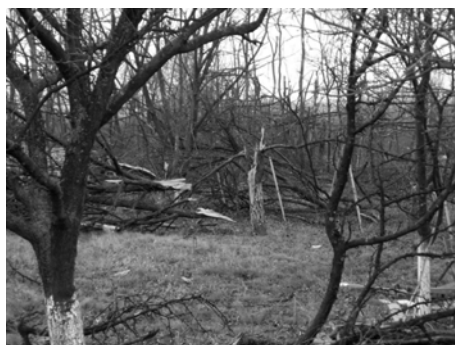
*The forest near the warehouse after the explosion*

In the very zone of the explosion all flora have been destroyed i.e. burnt down, while the forests in farther zone of explosion have also been considerably destroyed due to the shock wave.

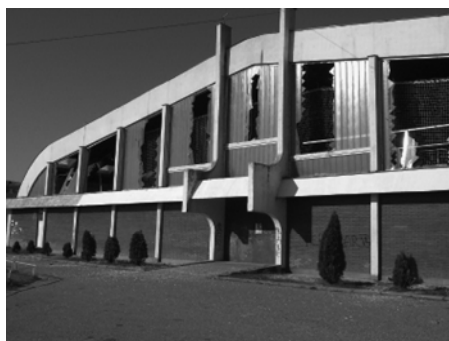
*Sports hall in Čuprija*

The shock wave has caused a number of damages to 4,470 buildings in the Municipality of Paraćin and about 4,200 buildings in the Municipality of Čuprija.
