MATERIALS AND TECHNIQUES IN OLD BRIDGE OF MOSTAR RECONSTRUCTION

Doc.dr. Maja Popovac dipl.ing.arh.
Faculty of civil engineering, Dzemal Bijedic University,
USC Midhat Hujdur Hujka, Sjeverni logor bb, Mostar
Bosnia and Herzegovina

ABSTRACT

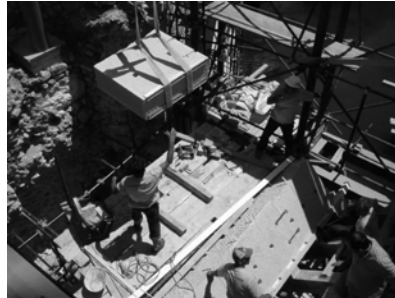
Figure 3. Assembling of the load bearing arch

Each arch stone was linked to one or two voussoirs of the preceding row by one or more metal dowels. Dowels were applied to the stone blocks in purposely carved slots, (holes), and melted lead was poured in the slots to connect metal and stone elements.

Adjacent voussoirs of each row were connected with double side cramps crossing the joints; even in this case cramps were linked to the stone by melted lead, poured in purposely built slots. Side cramps were quite regular, of similar shape and size and they had not so many variations along the load bearing arch.

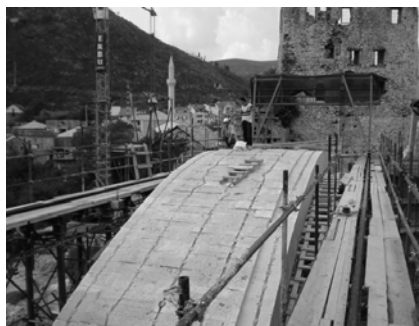
Figure 5. Extradados cramps

Extrados cramps were located over the extrados of the load bearing arch: there were five rows of cramps that ran in parallel directions following the curved profile. The extrados cramps acted like tying chains, or at least they were conceived with this purpose, being one adjacent to each other. These cramps were different from all the others that have been found in the bridge stone structure, because they were dimensioned depending exclusively on the arch stone measures: where one cramp ended, the other started, sharing the same stone-slot to allow continuity of the tying action.

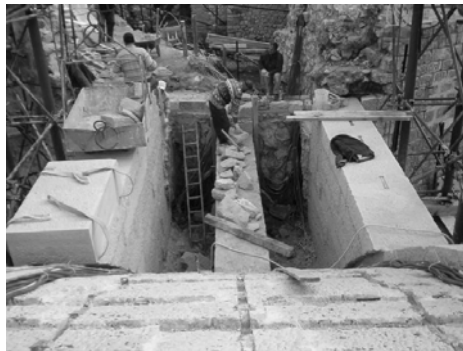
Figure 7. Assembling of the spandrel walls and middle rib

Spandrel walls were made in ordinary ashlar masonry work with thin mortar joints. On top side of the spandrels, across the joints, it was placed a single row of cramps approximately located along the longitudinal axis of the stone elements, but variability of this parameter was quite high being also related to the ashlar thickness dimensions. Stone block rows were sometimes assembled with an imperceptible gradient, may be due to ordinary constructive imperfections or to due to optimisation of the connection with the load bearing arch.
