## **DETERMINING DAMAGE ON AXIAL BOLSTERS OF THE RUNNING ENGINE OF A RAILWAY VEHICLE<sup>1</sup>**

*This paper presents the basic failures that appear on axial bolsters and bearings applied on railway vehicles. It describes the causes of damage on axial bolsters. The aim of this paper is to familiarize oneself with the problems of axial bolster maintenance and their importance from the aspect of railway safety.*

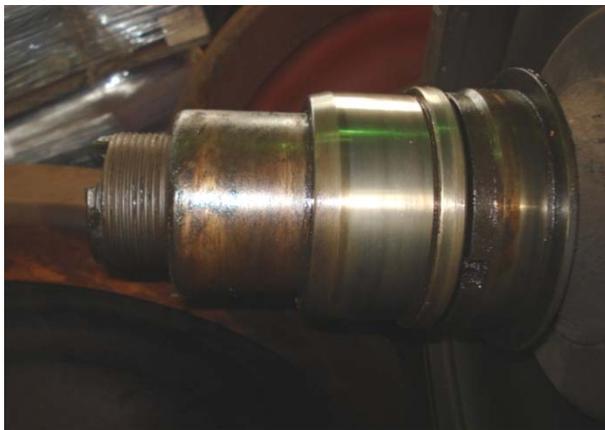
Corrosion and erosion leading to increased corrosion wear, which results in scarring. Corrosion of friction or corrosion circuit is created, but with a slight displacement between the inner ring and shaft sleeve and between the outer ring and housing (Fig. 2). [6] Loose assembly facilitates the movement of one part to another. Corrosion caused by wear of the bearing acts as a tool for grinding or polishing.

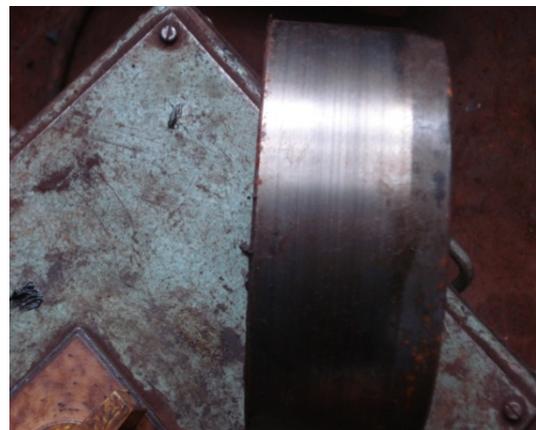
Roughness and listing on the path and cylindrical rollers is referred to as scaling.

It occurs due to fatigue, faulty installation of the bearing or the presence of foreign bodies.

Foreign bodies during assembly due to bearing the imprint of the path and cylindrical rollers and cause the formation of fine cracks from which the logs.[6]

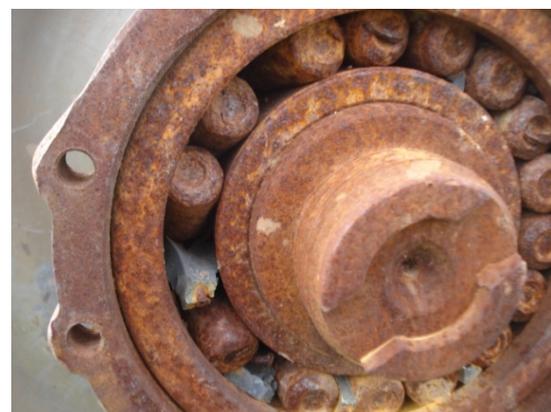
Figure 5. The consequences of lack of lubrication

The wear of the bearing cage eventually leads to fracture of the spacer and bearing damage (Fig. 5).

When insufficient lubrication occurs very wear pockets in the cage roller bearings, due to the cylindrical rollers which occupy an inclined position and cause damage to the bearing surface of the ring back and loosening of the joint with rivets. [6]
