TESTING, DAMAGE REPAIR AND ASSESSMENT SAFETY AND RELIABILITY OF SPHERICAL TANK STORAGE FOR EXPLOITATION'S EXTENSION OF LIFE

Sead Avdić
"INSTITUTE OF WELDING" d.o.o. Tuzla
Ul. Tušanj br.66, 75000 TUZLA
Bosnia and Herzegovina

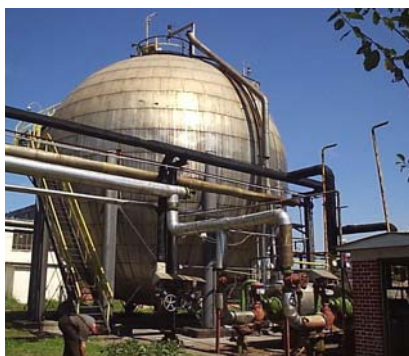
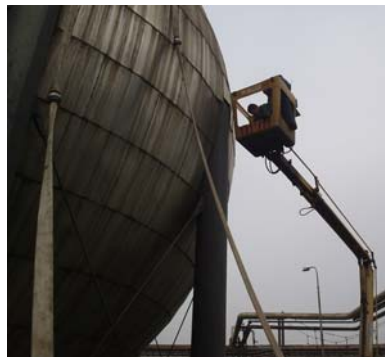
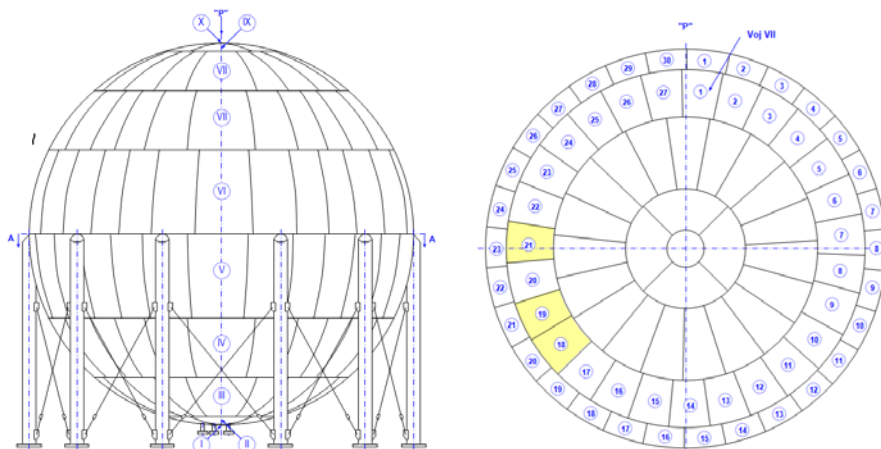
Figure 1. Spherical tank for ammonia storage and testing scheme

Spherical tank for storing ammonia was examined in accordance with a prescribed program of tests and applicable standards and regulations. Tests were performed with nondestructive methods according to instructions and regulations for the periodic inspection. There were applied penetrating, ultrasonic and magnetoflux methods. In some places of the storage tank were discovered corrosion damages in depth of 5-10 mm, especially in section 18 and 21 of the part VII. In section 19 of the part VII damages showed concentration of a large number of small cracks, so that made crop a plate size 190 x 280 mm. Local damages sanitation was done by welding and replacement of damaged and diced segments was done by welding, manual arc welding process according to the prescribed technology.
