DIAGNOSIS OF A MILL USED FOR POWDER SLAKED LIME MANUFACTURING

ABSTRACT

The main aim of this paper is to present the methodology and the experimental set-up used to determinate the causes of the gearbox crack of a mill used for powder slaked lime manufacturing. There are presented the equipment used, the methodology of equipment calibration and the realised measurements. At the end there are mentioned the main causes that can develop the gearbox frame collapse.

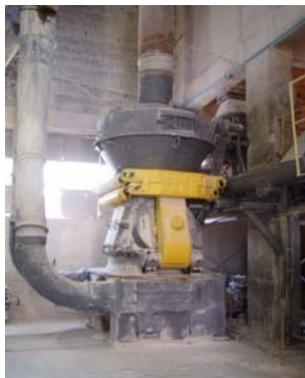
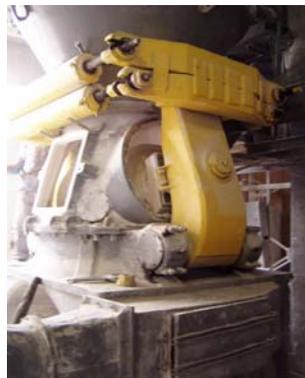
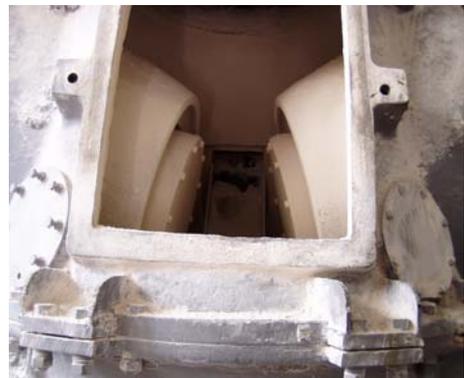
Figure 1. Times new roman font, italic 11-pt. There should be one line space between figures and text.

During the technological process of the powder slaked lime manufacturing there are used large mills (Figure 1,a & b) where slim balls are pressed in a system consisting of a rotating table and two pressing rolls (Figure 1,c). As a result of the technological process there are developed shock impulses with large amplitude that can have a bad influence on different parts of the mill. The most affected part of the whole mill is the gearbox that is situated between the electrical engine that provide the rotation motion and the rotating table. As a result of the shocks impulse the frame of the gearbox cracked around its base (Figure 2).

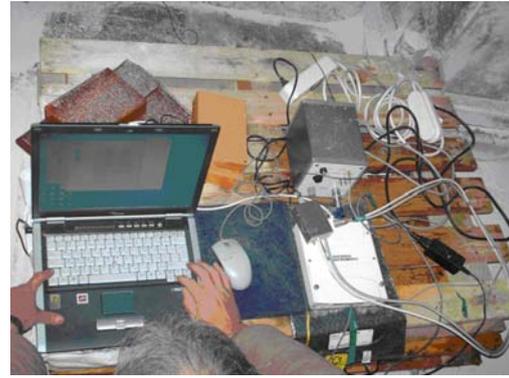
Figure 3. Measurement set-up

The measurement set up consists of the following components: accelerometers type KD23 and 12, data acquisition setup *National Instruments DAQPad-6015* (16 bit, 200 kS/s, USB), laptop *Fujitsu-Siemens* (512 Mb, Pentium 4, 1,8 GHz) and different accessories (Figure 3).

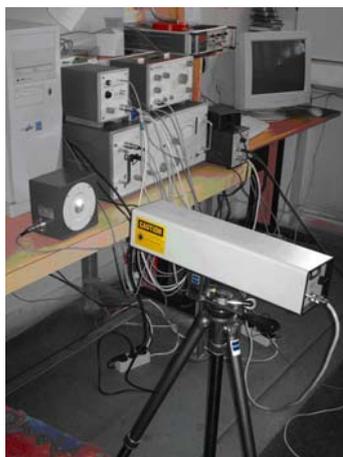
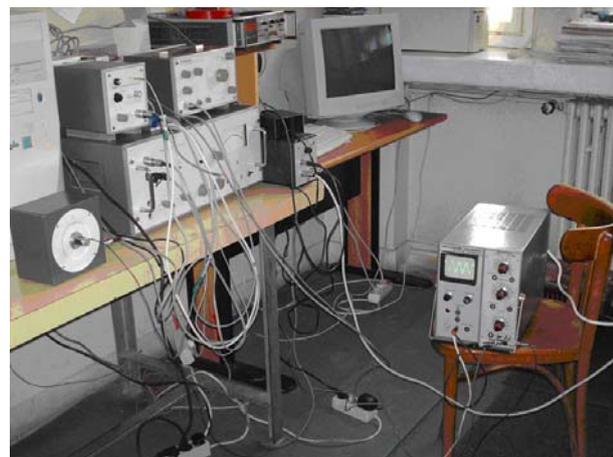
Figure 4. Calibration system

The calibration activity was focused on establishing if the used accelerometers have the prescribed sensitivity that is given by the producer. The calibration set-up consists of: signal generator *E0502M*, scope *E0102*, power amplifier *AE 101 type 11072* (Messelectronic RFT), calibration system type *11072* (Messelectronic RFT), Laser velocity transducer *TYPE 3544* (Bruel&Kjær); accelerometers type *KD23* and *KD12*; acquisition data system *National Instruments DAQPad-6015* (16 bit, 200 kS/s, USB); preamplifier *RFT tip 20027*; PC *Pentium 4, 3GHz*, and Soft *TEST Point – Keithley Instruments Metrabyte și LabView*.
